TECH TIPS — *Subject:* Reverse Grinding or Not Staying Engaged
Model: All Models with Reverse or Reverse Kit

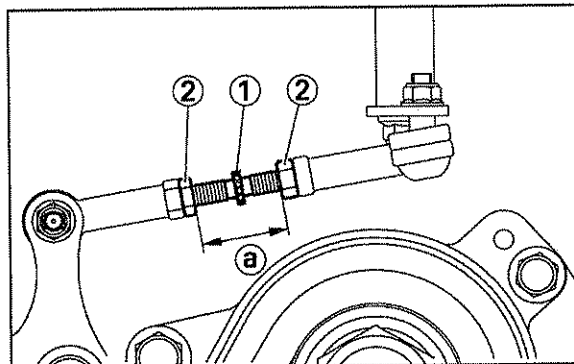
Adjusting Step 1 – Upper Linkage

Reverse grinding or not engaging properly when attempting to shift into reverse. The unit may also not disengage properly when shifting from reverse.

Incorrect shift linkage adjustment at two different locations.

1. Loosen the locknuts ②.
2. Turn the threaded adjuster ① to set the length ③ to 27mm.
3. Tighten the locknuts ②.
